Flying roadside stones—a deadly risk in a crash

Abstract: The crash of a coach with 58 occupants at 100 kmph revealed the danger of covering ditch areas with sharp stones 5–20 cm in size. Stones and dirt were sprayed into the coach compartment resulting in serious injuries and death. Road safety works need to address this factor in the future.

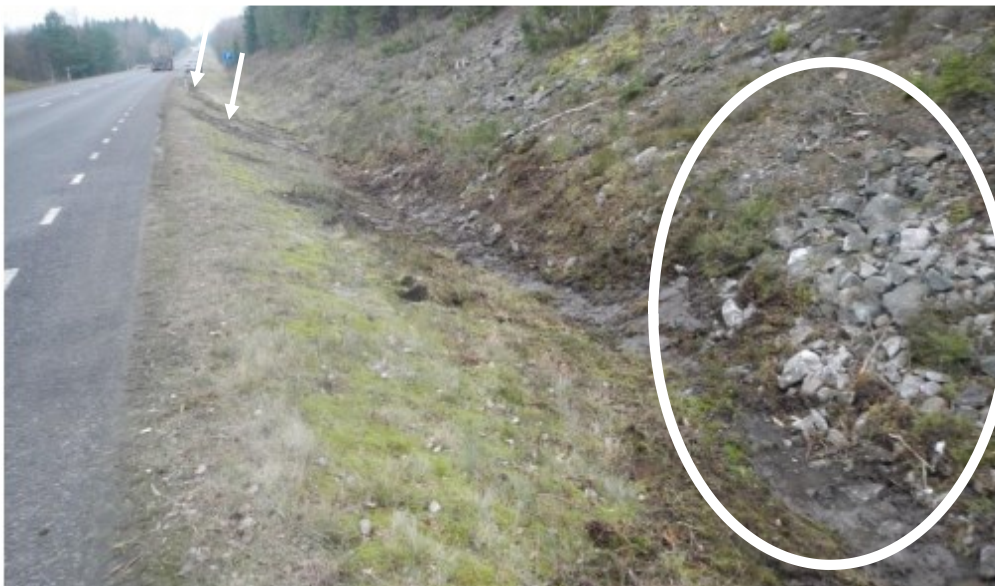
Figure 1. The stones and dirt at a site where a coach with 58 occupants went off the road at 100 km/h because the driver was incapacitated. Photo: *SHK (2015)*

Roadside hazards such as concrete pillars and lampposts are well-known risk factors for vehicles that leave the road as, for example, noted by *Rechnitzer & Grzebieta (1999)*. Many road design rules have been established with the aim of reducing the consequences of a crash. However, a coach crash at 100 km/h has revealed the danger of material currently used on roadsides in Sweden (Figure 1).

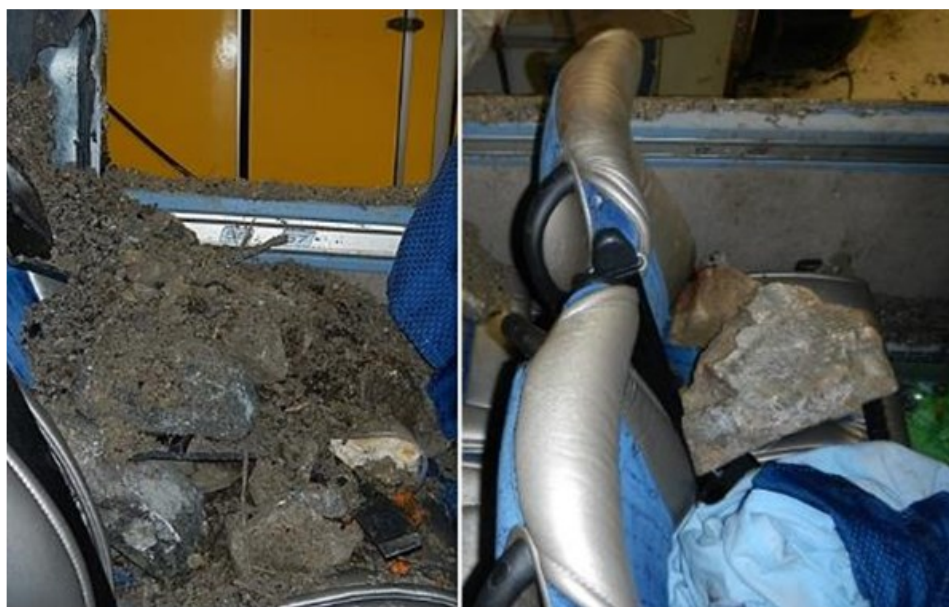
When the left side of the coach hit the ground, all the windows on that side broke and stones and dirt were thrown into the coach (Figure 2). Of the 15 passengers sitting in the window row on this side of the coach, 10 sustained serious or more severe injuries (MAIS 3+) (*AAAM, 2008*), many due to the stones and dirt that came flying into the coach. Four passengers had body parts (head, arm) partly ejected through the crushed window. They were injured by impact with the ground, and/or got their arms crushed between the side of the coach and the ground. Of these 15 injured passengers, 12 had used seat belts. One passenger in one of the ‘safest seat positions’ (according to several coach crash investigations) in the row nearest the aisle in the rear, sustained fatal head and neck injuries caused by a 5 kg/10×20 cm stone (right-hand picture in Figure 2).

Figure 2. Interior of the left side of the coach, showing stones and dirt sprayed into it and onto passengers during the crash at 100 km/h. Photo: *SHK (2015)*

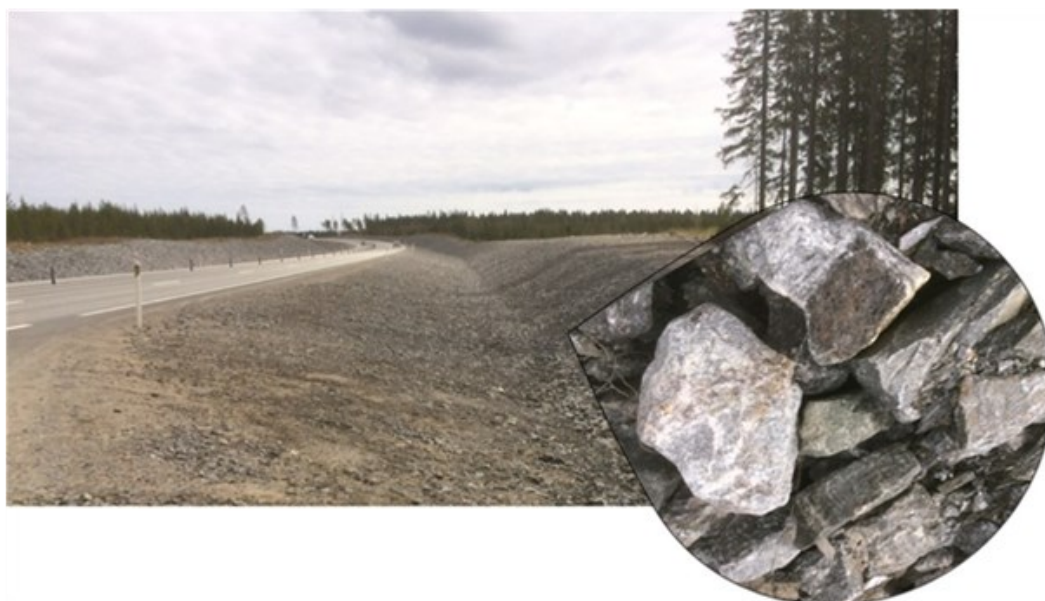
Figure 3. Recently built bypass around a Swedish city, belonging to the ‘Trans European Network’ of roads which in Sweden must be processed through a ‘Road Safety Audit’ during the building process. Clearly, the risk presented in this paper has not been taken into account. Photo: *Ulf Björnstig*

The risk of using this type of roadside material has not been discussed much. This case report may be an eye-opener in that regard, as any vehicle leaving the road—particularly at a high speed—would expose the occupants to this serious risk of injury if overturned. Gravel or sand traps are effective, on racing tracks, at safely reducing the speed of a crash; however, the roadside material used here seems to be very dangerous. This injury risk needs to be accounted for when new roads are built (Figure 3) or when the safety of current road systems are evaluated.
